**PRELIMINARY ASSESSMENT/
VISUAL SITE INSPECTION**

**AGI, INC.
MELROSE PARK, IL
ILD 047 580 006**

FINAL REPORT

Work Assignment No.	:	C05087
EPA Region	:	5
Site No.	:	ILD 047 580 006
Date Prepared	:	March 1, 1993
Contract No.	:	68-W9-0006
PRC No.	:	009-C05087IL2A
Prepared by	:	B&V Waste Science and Technology Corp. (Michael Eng, Anil Saxena, and Margie Casserly)
Contractor Project Manager	:	Shin Ahn
Telephone No.	:	(312) 856-8700
EPA Work Assignment Manager	:	Kevin Pierard
Telephone No.	:	(312) 886-4448

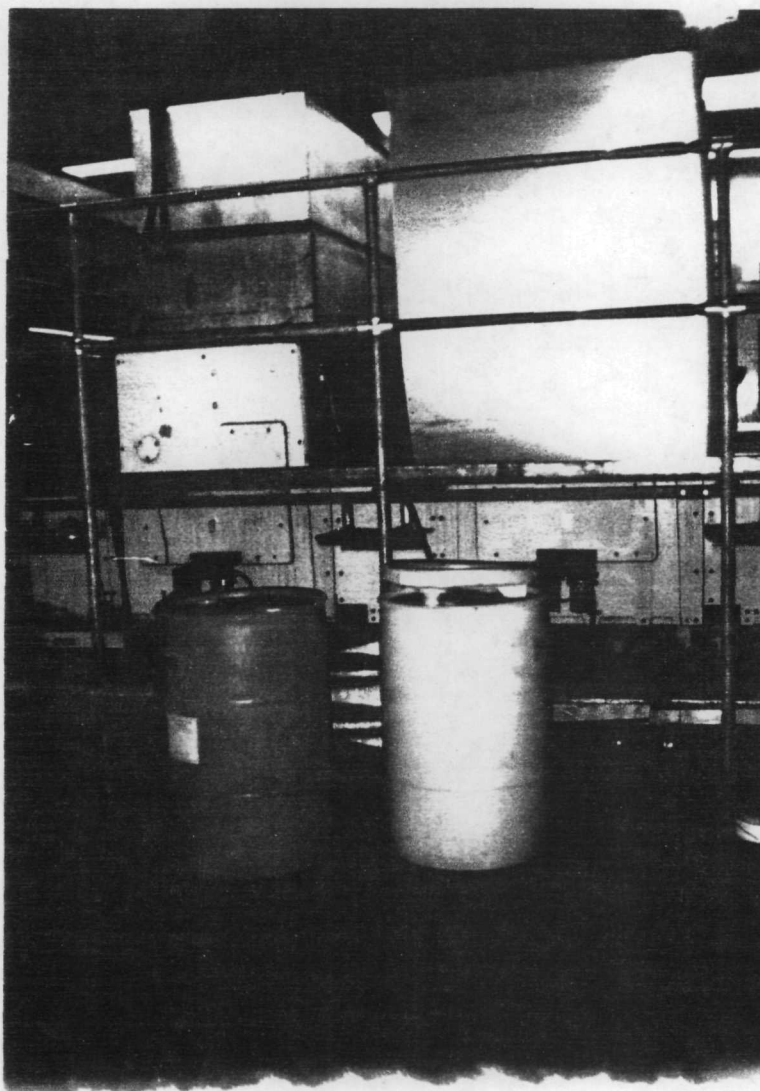
Photograph No. 1

Location: SWMU 4

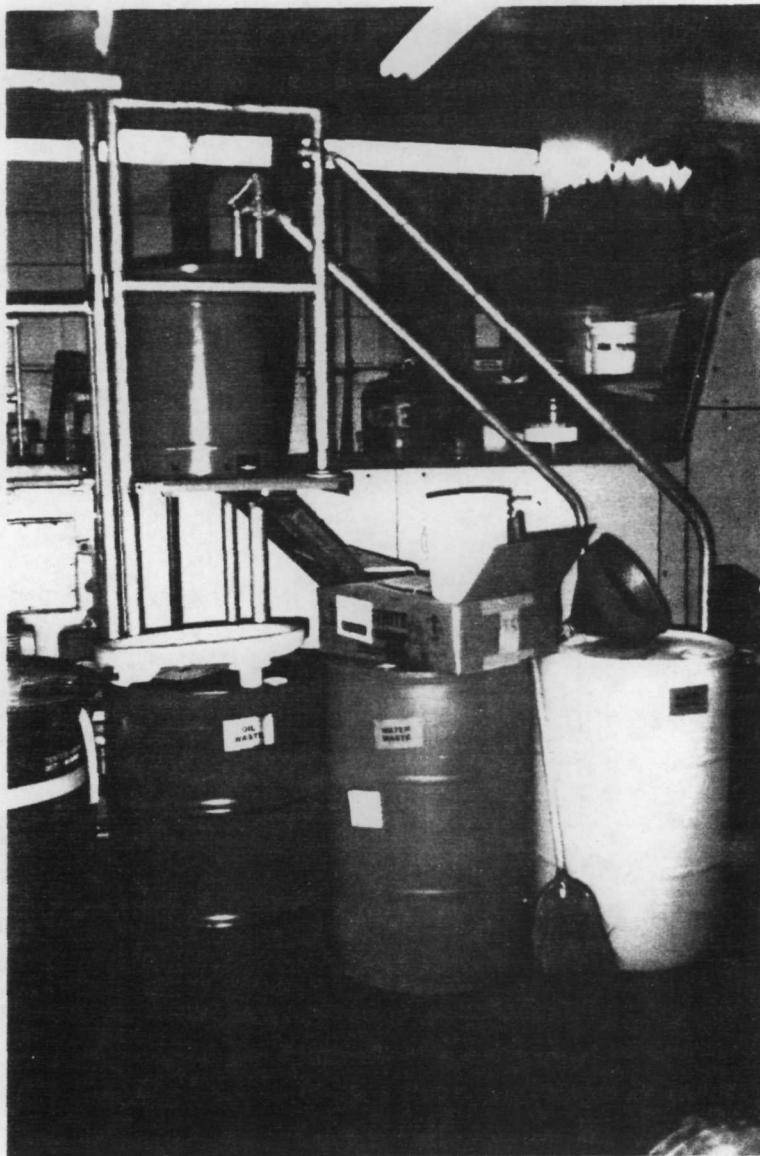
Photograph No. 2

Location: SWMU 4

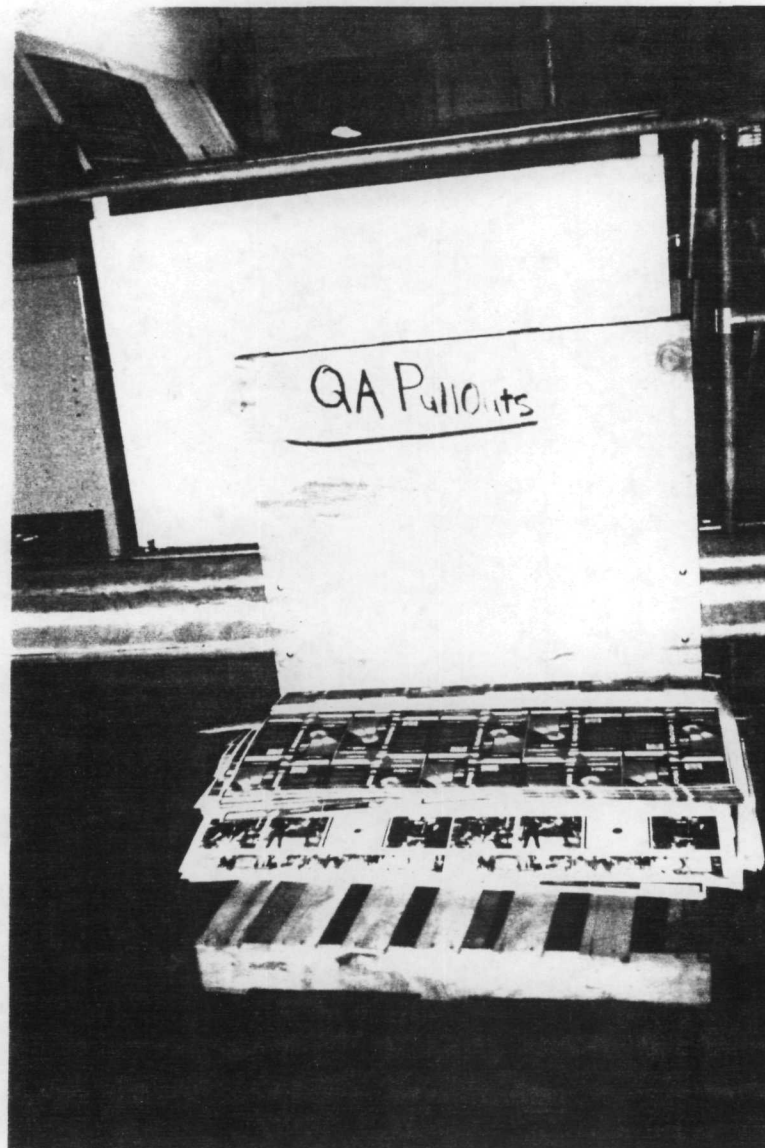
Photograph No. 3

Location: SWMU 4

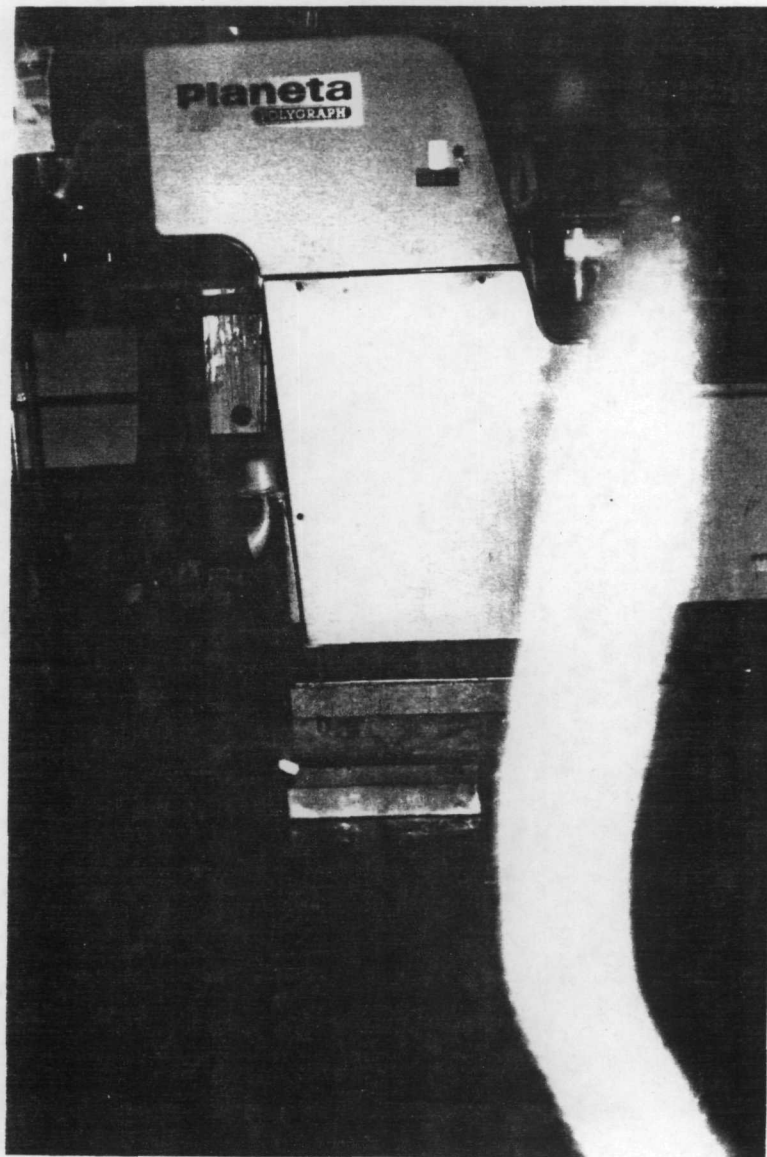
Photograph No. 4

Location: SWMU 4

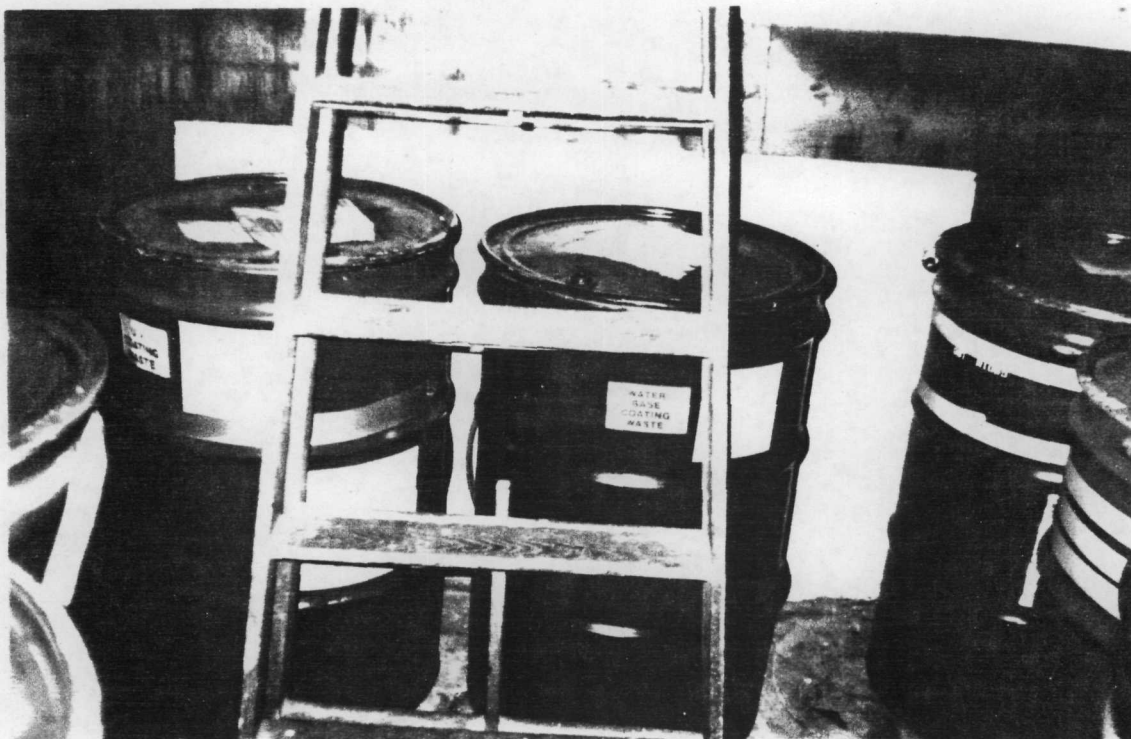
Photograph No. 5

Location: SWMU 6

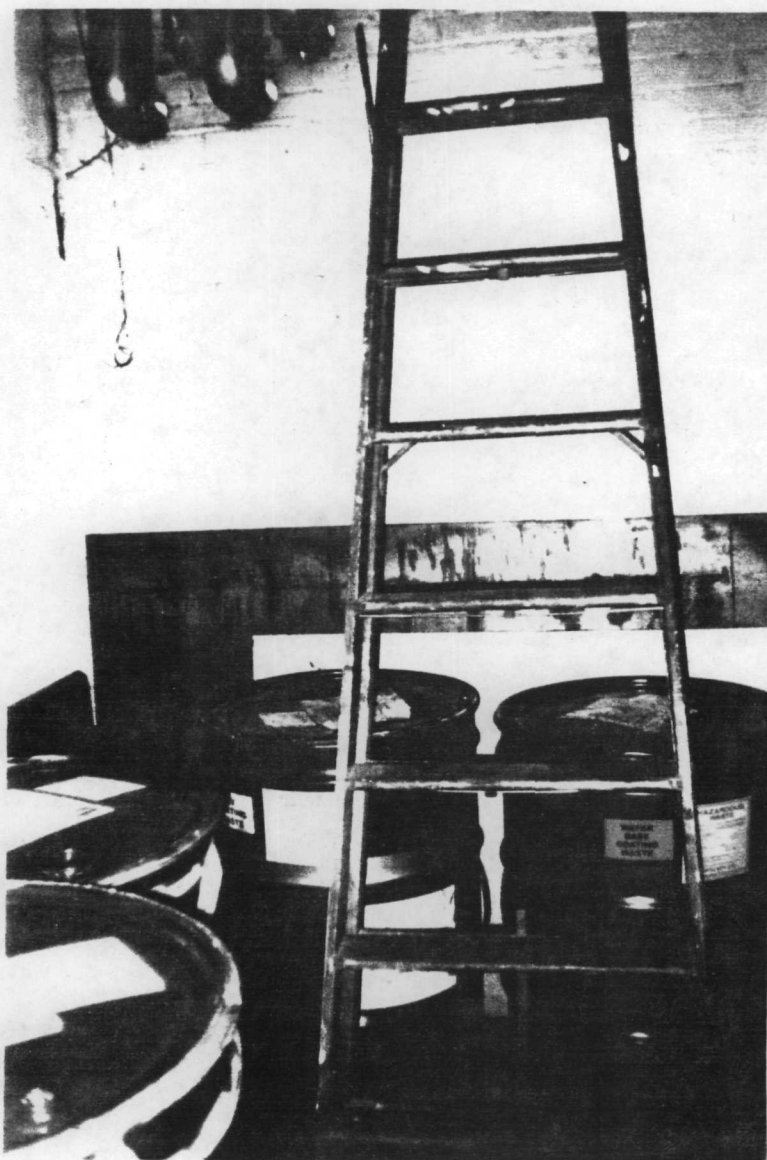
Photograph No. 6

Location: SWMU 6

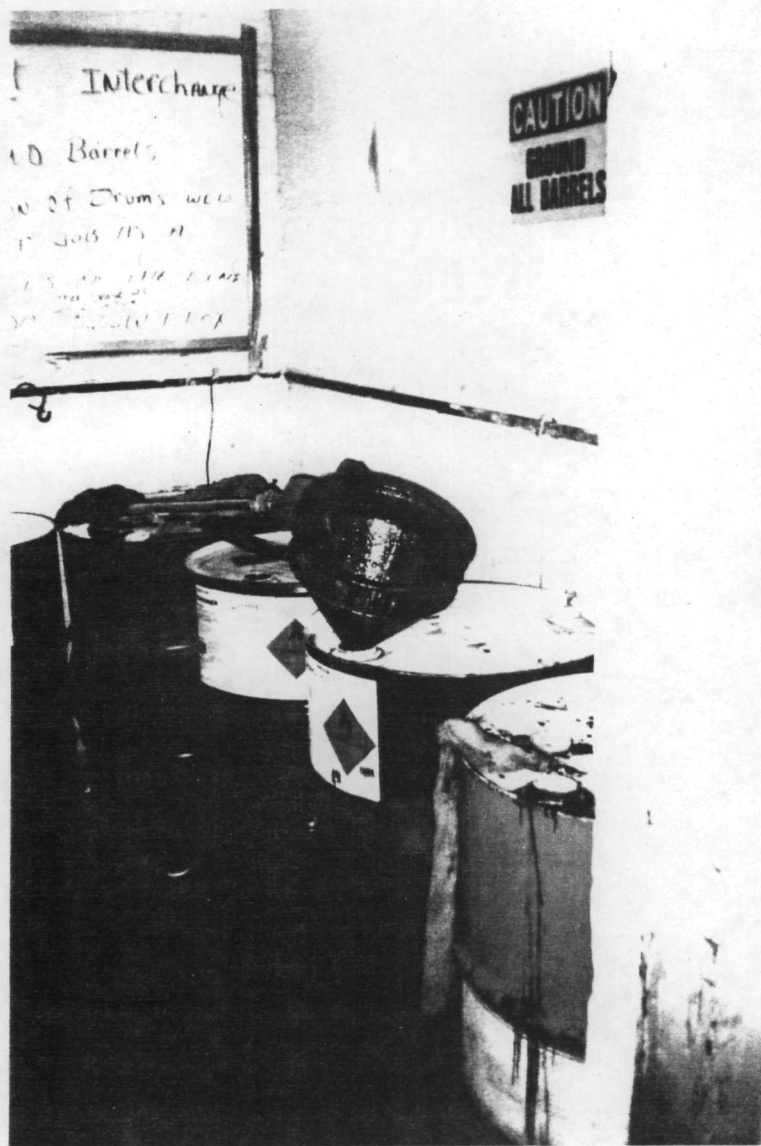
Photograph No. 7

Location: SWMU 5

Recommendations: BVWST suggests that drums must be closed except when it is necessary to add or remove waste, and that full drums be removed from the unit within three days.

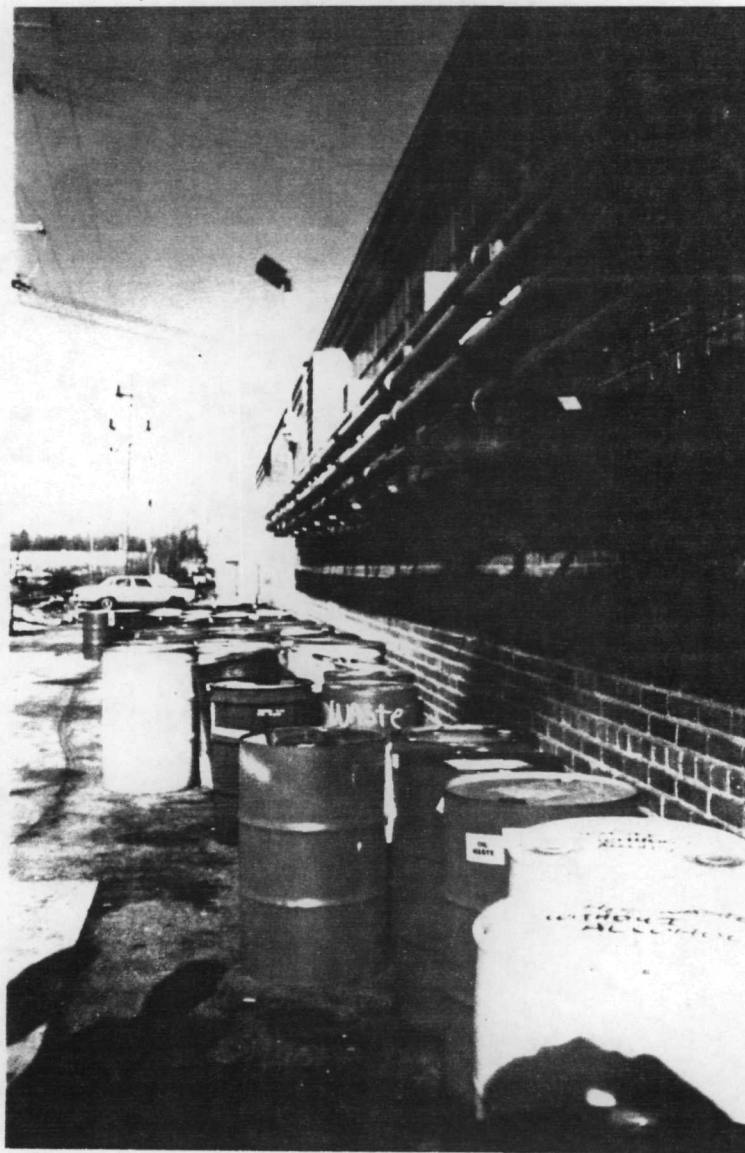
Photograph No. 8
Orientation: North

Location: SWMU 8
Date: 12/10/91

Description: Final staging area for all wastes, except paper, to be picked up by Safety-Kleen.

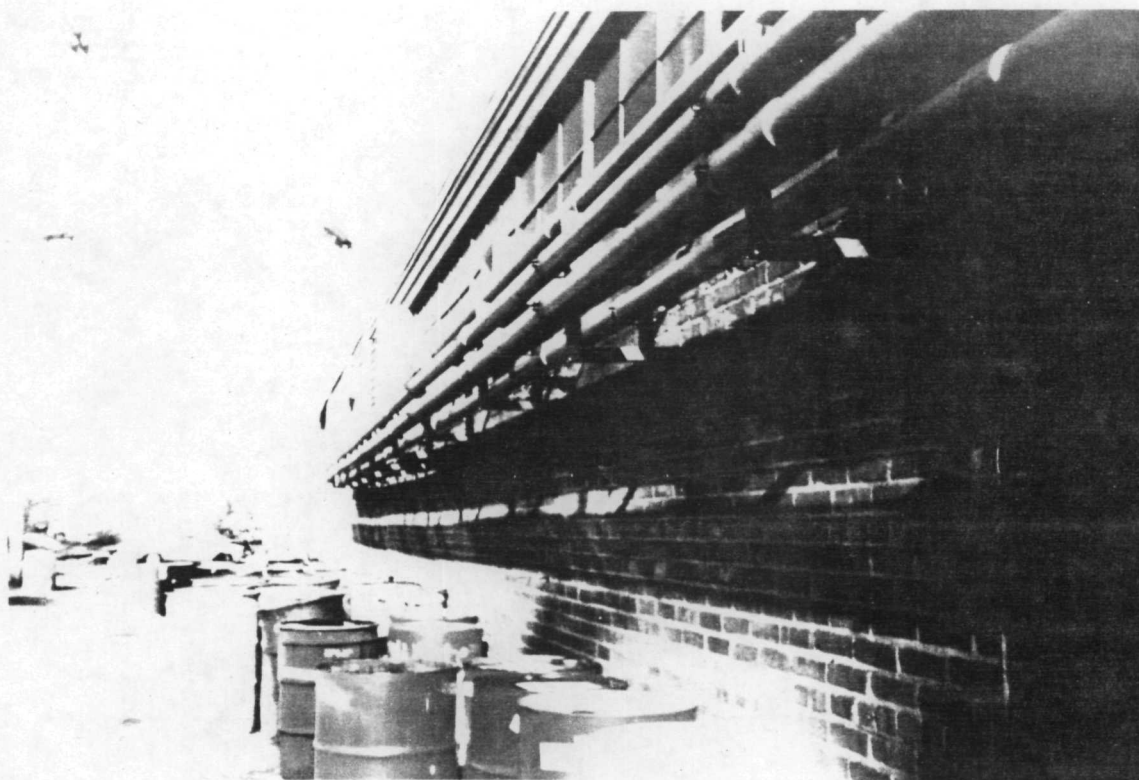
Photograph No. 9
 Orientation: North
 Description: Facing the final staging area.

Location: SWMU 8
 Date: 12/10/91

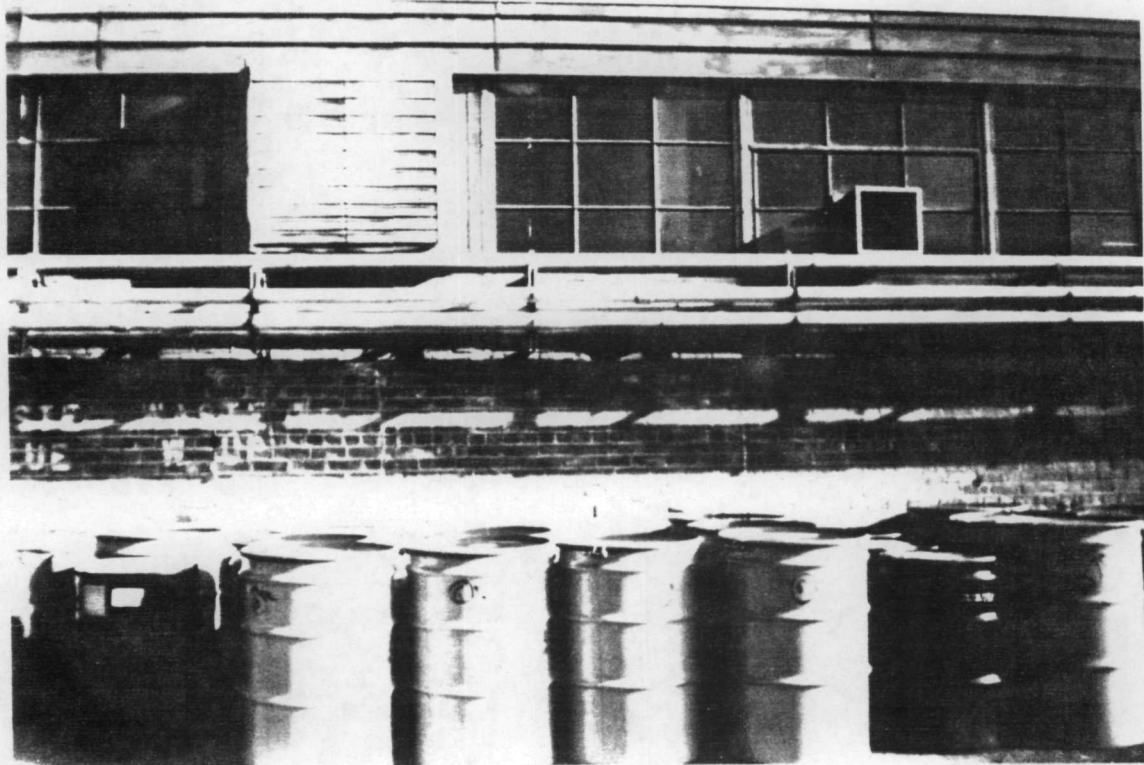
Conclusions: A moderate potential for release to the soil and ground water exists. The drum storage pad is upgradient of the slope that leads to the railroad tracks behind the facility. AGI recently covered and overpacked 26 drums containing an unknown substance. The condition of the drums and length of time they were uncovered are unknown. Because these drums remained outdoors on an uncurbed asphalt pad for an unknown period of time, the possibility of a release to air and surface soil exists.

Photograph No. 10
 Orientation: East
 Description: On the Drum Storage Pad (SWMU 8) facing overpack drums of unknown wastes.

Location: SWMU 8
 Date: 12/10/91

Recommendations: Soil sampling on the sloping area of the drum storage pad.

BVWST recommends that drums be stored in accordance with 40 CFR Part 265 Subpart I, or with an approved variance.

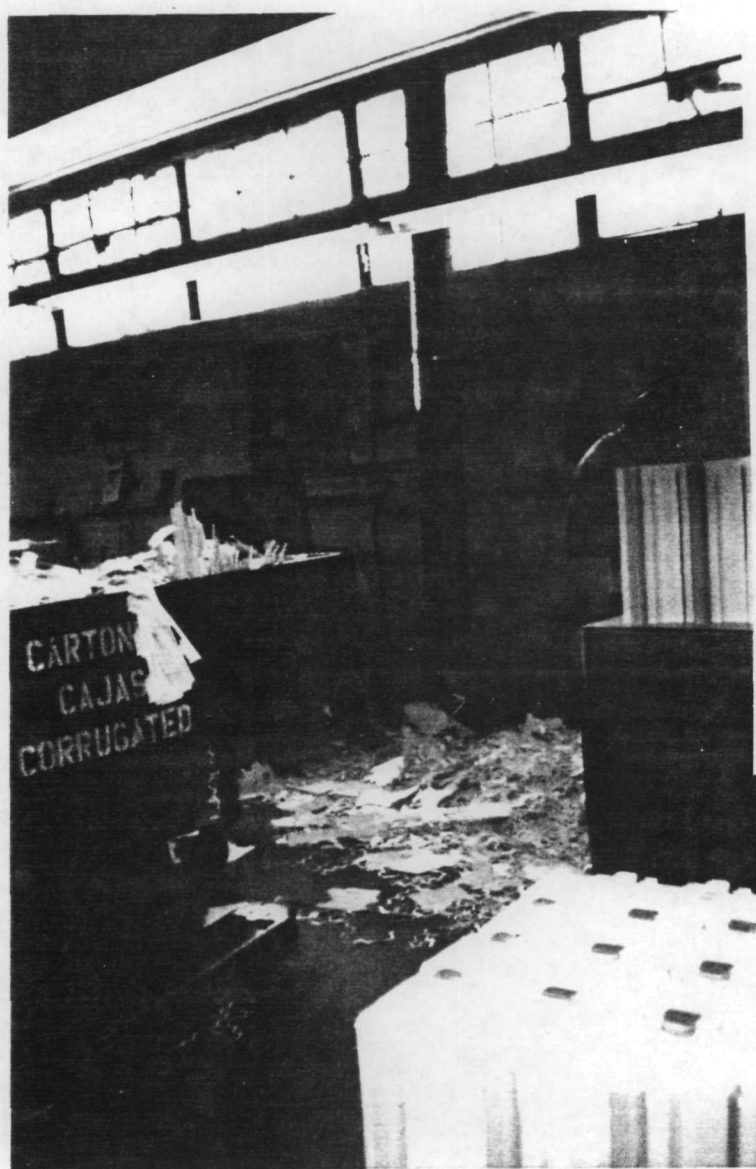
Photograph No. 11

waste paper. This unit is not used to manage hazardous materials. No evidence of a release was observed.

Location: SWMU 1

Recommendations: No further action is recommended.

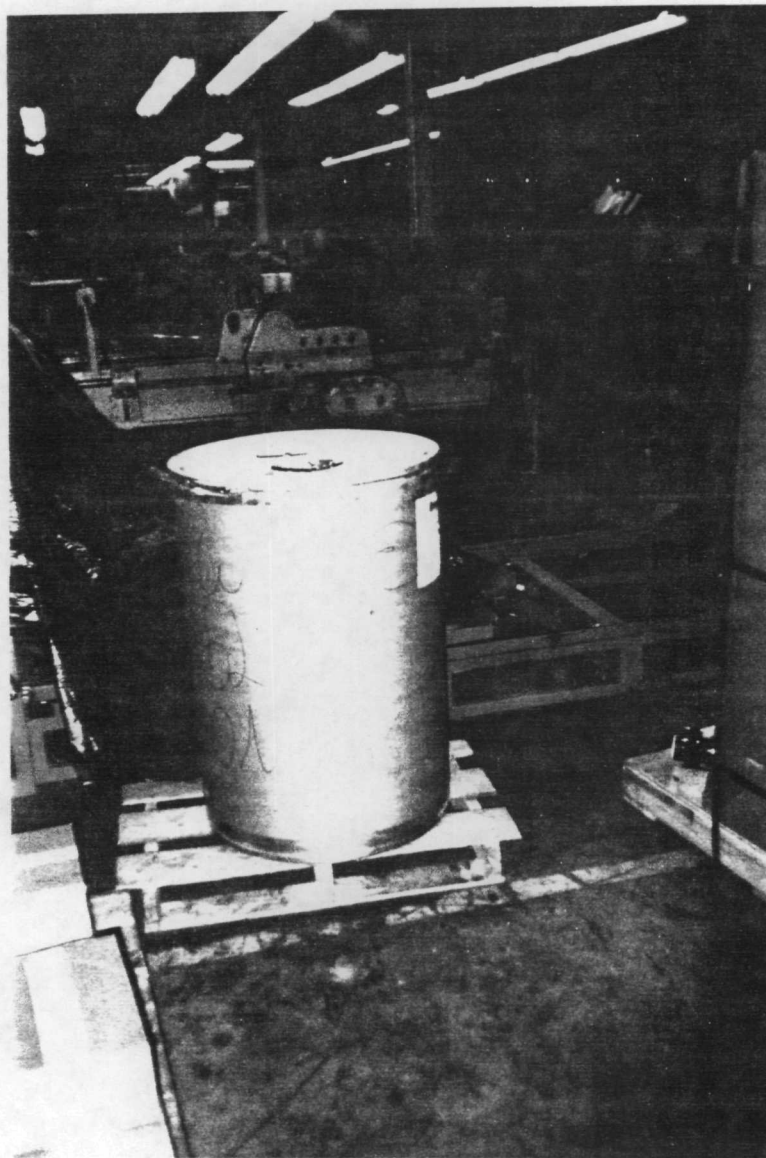
Photograph No. 12

This drum was about 50% full of the flammable adhesive during the VSI. The floor had no visible signs of cracks. No evidence of a release was observed.

Location: SWMU 7

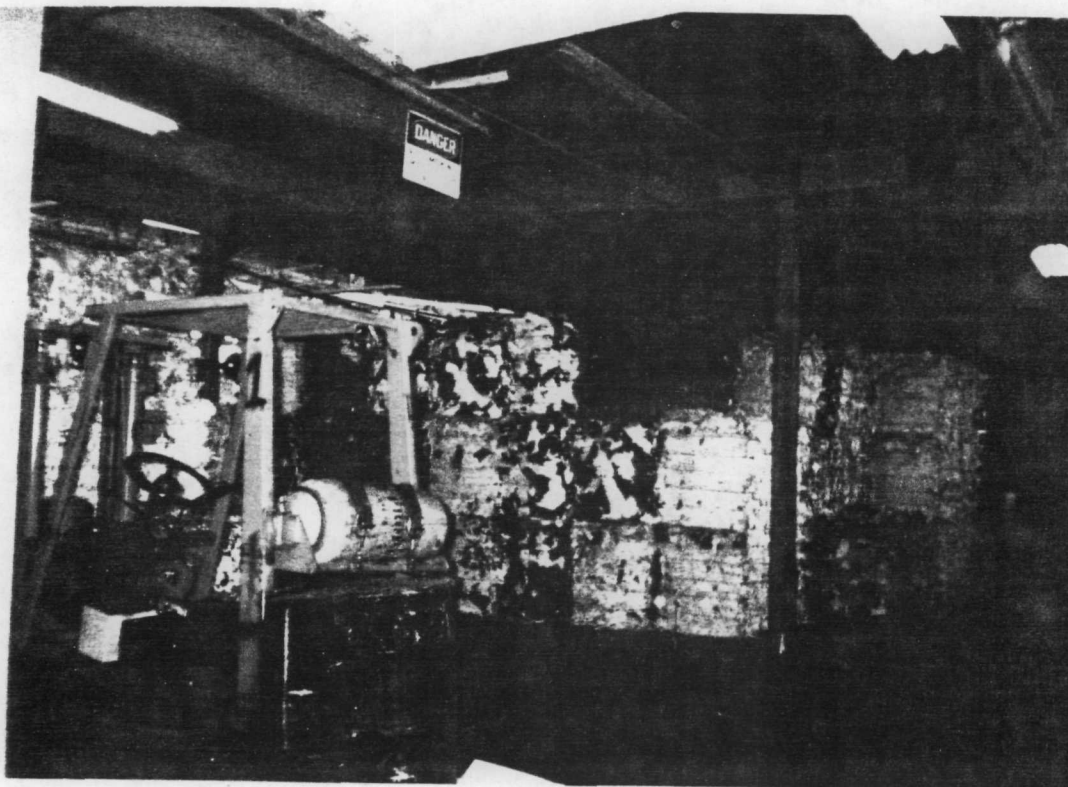
This unit contained about 25 bales of various grades of waste paper during the VSI. This unit is not used to manage hazardous materials. No evidence of a release was observed.

Photograph No. 13
Orientation: Southwest
Description: Baled paper in its final staging waiting for resale.

Location: SWMU 2
Date: 12/10/91

Recommendations: No further action is recommended.

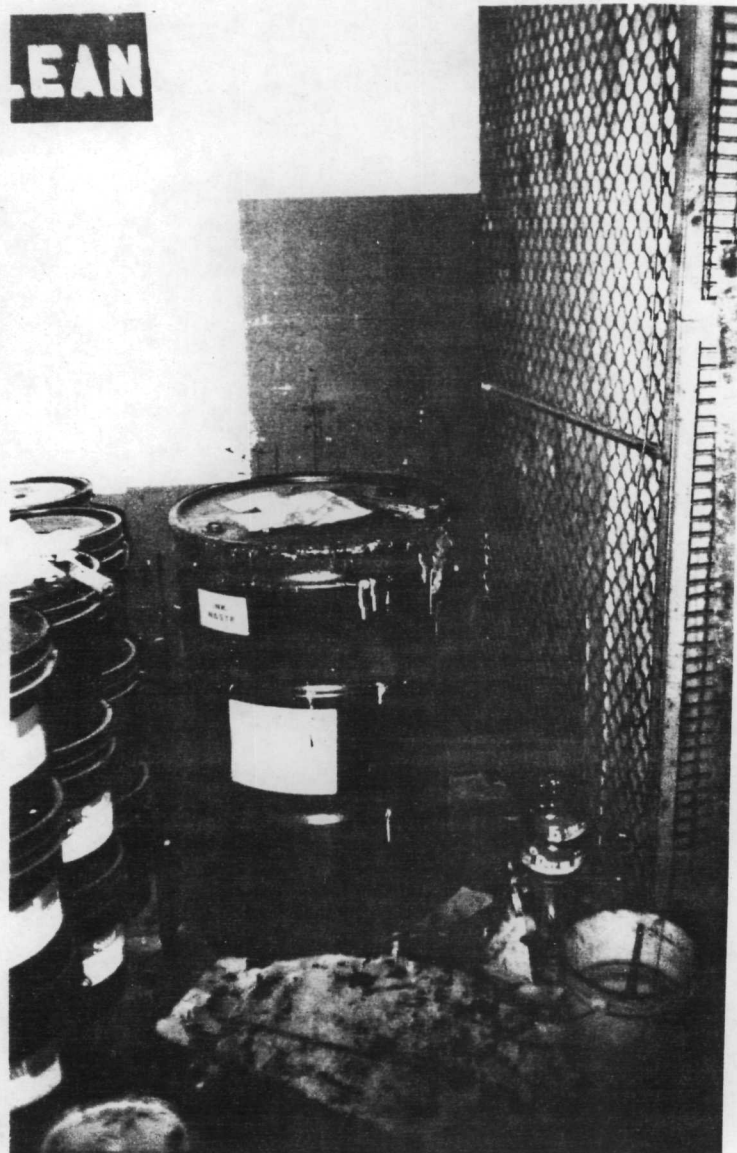
Photograph No. 14

Observations: The unit contained about 25 gallons of waste ink. In Photograph No. 14, the drum lid is in place but is not secured. Full, open cans of waste ink are setting on the floor by the drum. No evidence of a release was observed.

Recommendations: BVWST recommends containers of waste be maintained closed.
